Original Article

## Evaluation of root repair using an environmental scanning electron microscope after intentional contact with microscrew

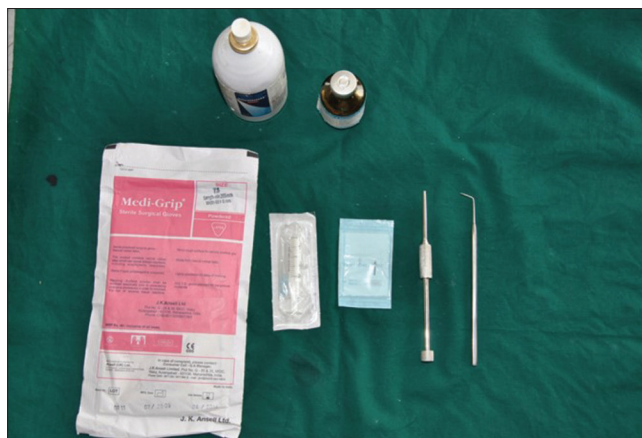
Figure 1: Armamentarium used for the study.

7. Periodontal Probe for standardization [Figure 1]
8. E-SEM (Environmental Scanning Electron Microscope study) - Icon Analytics Quanta 200.

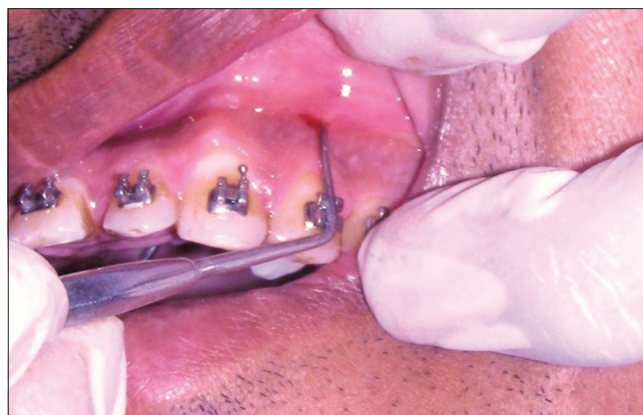
Figure 2: Placement of the Probe.

Microscrew implants were placed in such a way that they were in direct contact with the buccal root surfaces of the first premolars (directly hit the root from the buccal aspect) of the maxillary and mandibular arches to be extracted for the orthodontic treatment purpose. To determine the position of placement of implants a periodontal probe was used and the same distance of that probe was maintained from the brackets for which the brackets were bonded on the premolars to be extracted, in each of the patients [Figure 2].

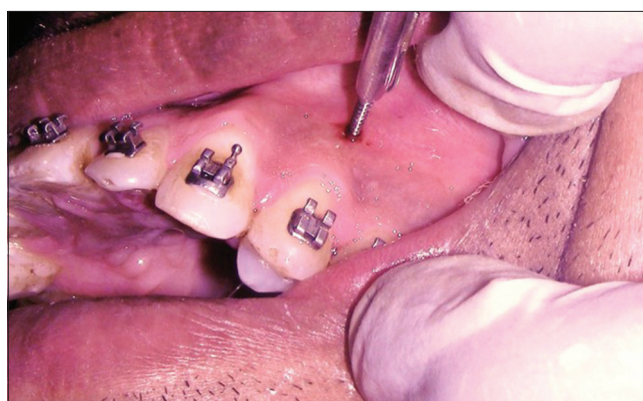
Figure 3: Implant directly hitting the root surface.

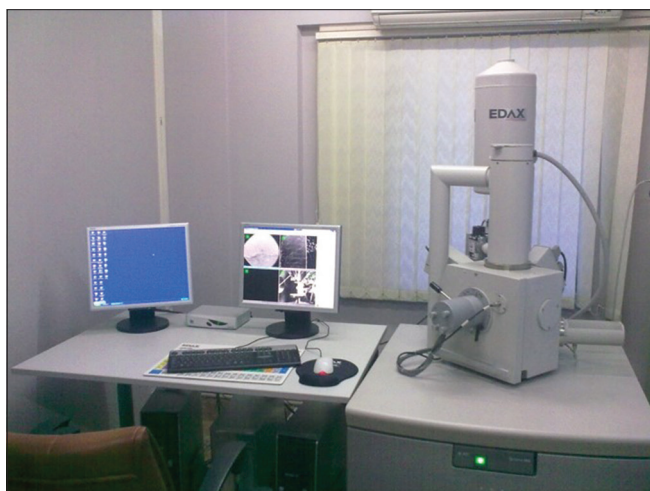
**Figure 4:** Environmental Scanning Electron Microscope, Icon Analytics Quanta 200.

taking place in the damaged root surface area [Figure 4]. The evaluators performing ESEM analyses were blinded.
